Zimbabwe

Quantifying destruction - satellite images of forced evictions

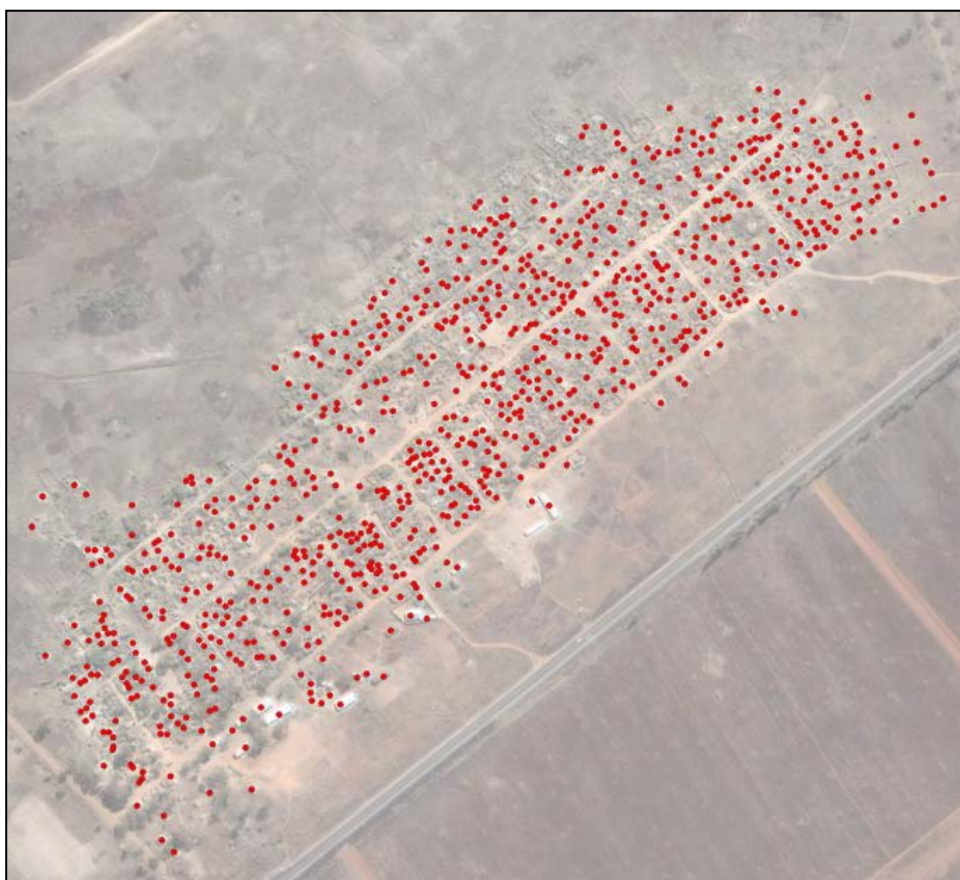
Visual analysis of the 2002 image was undertaken to determine the approximate number of structures removed during the interim period. Specifically, the 2002 image was loaded in ArcView GIS and individual visible structures were counted (see Figure 2). A total of 870 structures were counted. The majority are absent from the “after” image. Based on image analysis, more than 850 structures were apparently removed during Operation Murambatsvina.

The dimensions of the settlements and its structures were also measured, indicating a long axis of 1017 meters and a short axis of 257 metres for Porta Farm. The size of the structures themselves varied quite widely, with small structures measuring four meters on a side and larger structures measuring up to 40 square meters and more.

Figure 2: Porta Farm Structure Count
The Porta Farm settlement with centre points of destroyed structures.
Images (C) COPYRIGHT 2006 DigitalGlobe, Inc. ALL RIGHTS RESERVED

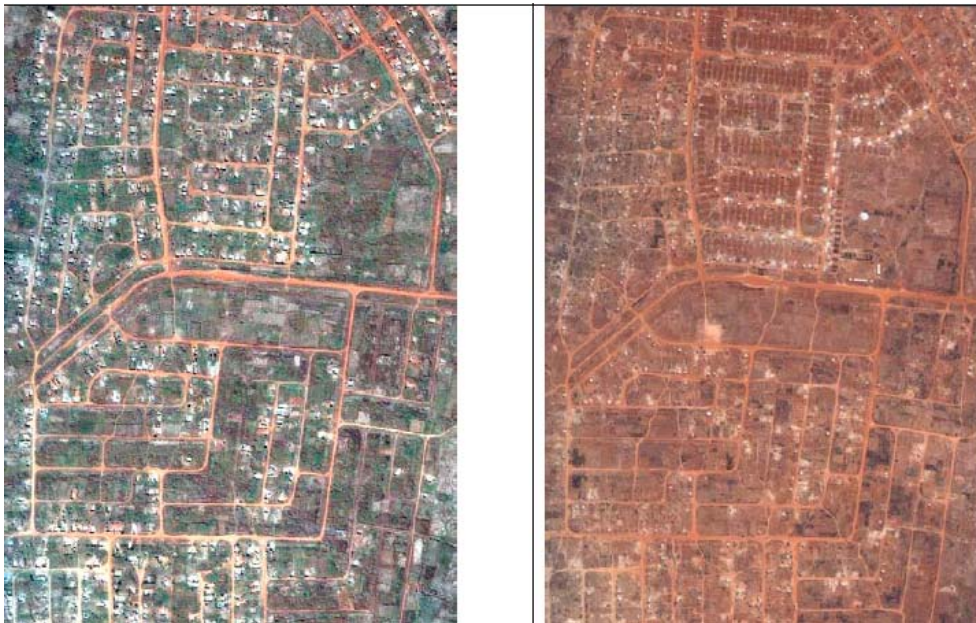
Four QuickBird images were obtained.⁷ The first set of images (Figure 3) shows a “before” image from 14 May 2004 and an “after” image from 2 September 2005 of the area of Hatcliffe Extension known as Hatcliffe Extension New Stands. The satellite imagery clearly shows the settlement in 2004 while the 2005 image shows most homes removed.

Figure 3: Hatcliffe Extension New Stands Before and After Operation Murambatsvina
High resolution satellite imagery of the Hatcliffe Extension New Stands settlement in Zimbabwe. More than 700 structures are visible in the before (left hand) image, most of which are absent from the after (right hand) image. Note that the significant difference in colour between the images is due to seasonality as the before image was captured during the dry season while the after image was acquired during the rainy season.

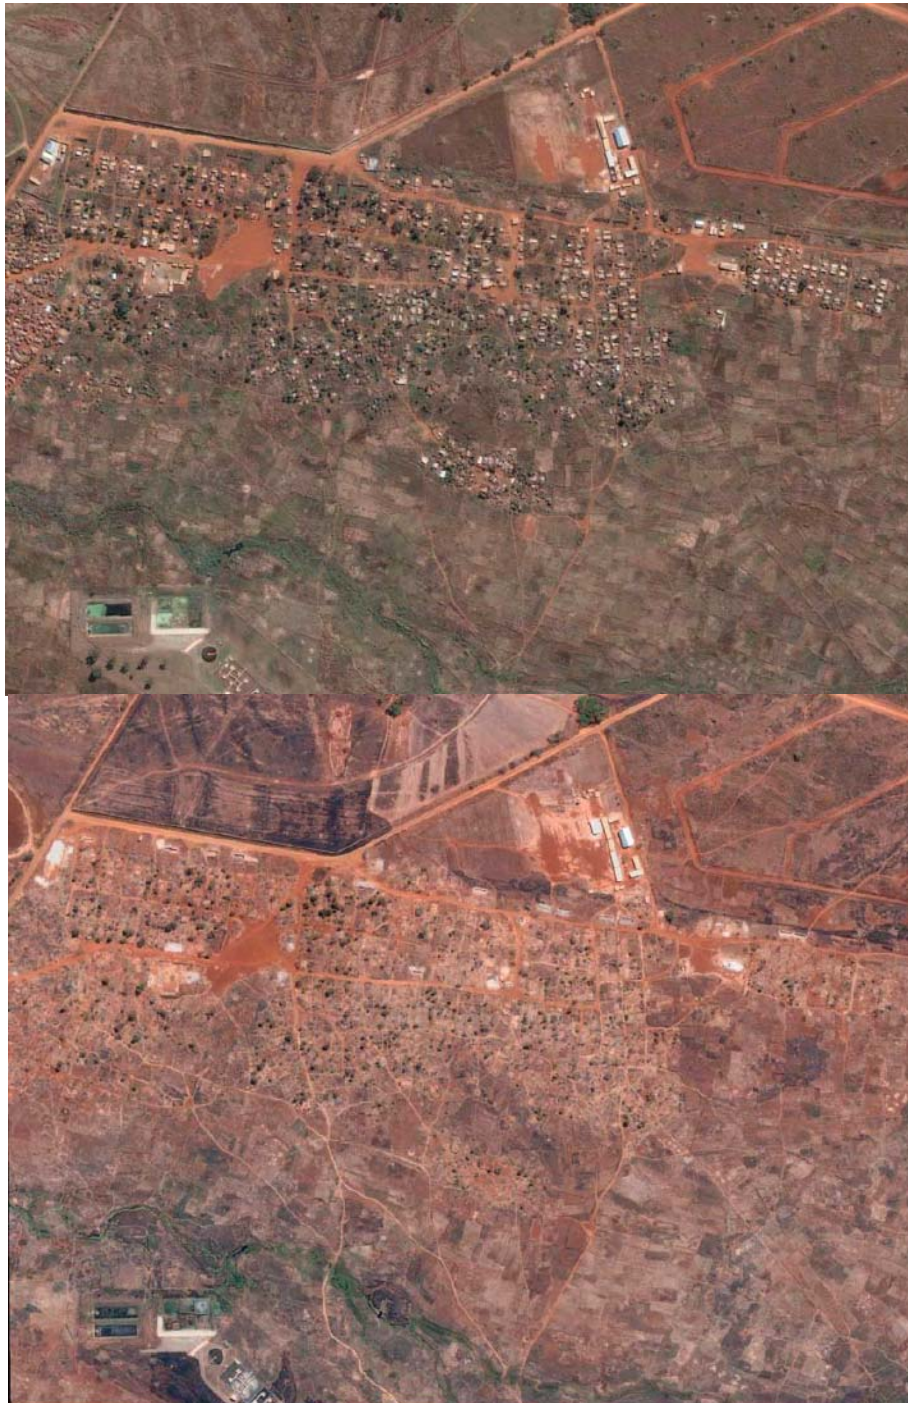
Figures 6 and 7: Hatcliffe Extension Holding Camp Before and After Operation Murambatsvina
These images show a “before” image from 14 May 2004 and an “after” image from 2 September 2005 of Hatcliffe Extension Holding Camp.

As before, the images were analysed to determine the approximate number of structures destroyed. This analysis revealed a total of 764 structures visible in the “before” image of Hatcliffe Extension New Stands and 875 structures visible in the “before” image of Hatcliffe Extension Holding Camp, which were absent from the “after” images. In addition, an undetermined number of backyard structures were also possibly removed from the nearby formal suburb of Hatcliffe.

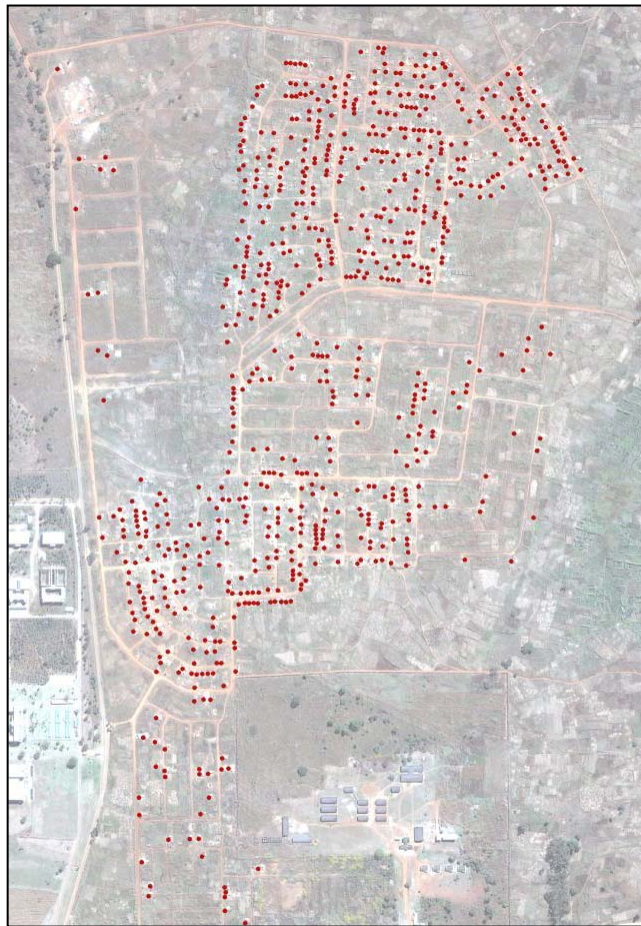
Figure 8: Hatcliffe Extension New Stands Structure Count

The Hatcliffe Extension New Stands settlement with centre points of destroyed structures. Images (C) COPYRIGHT 2006 DigitalGlobe, Inc. ALL RIGHTS RESERVED.

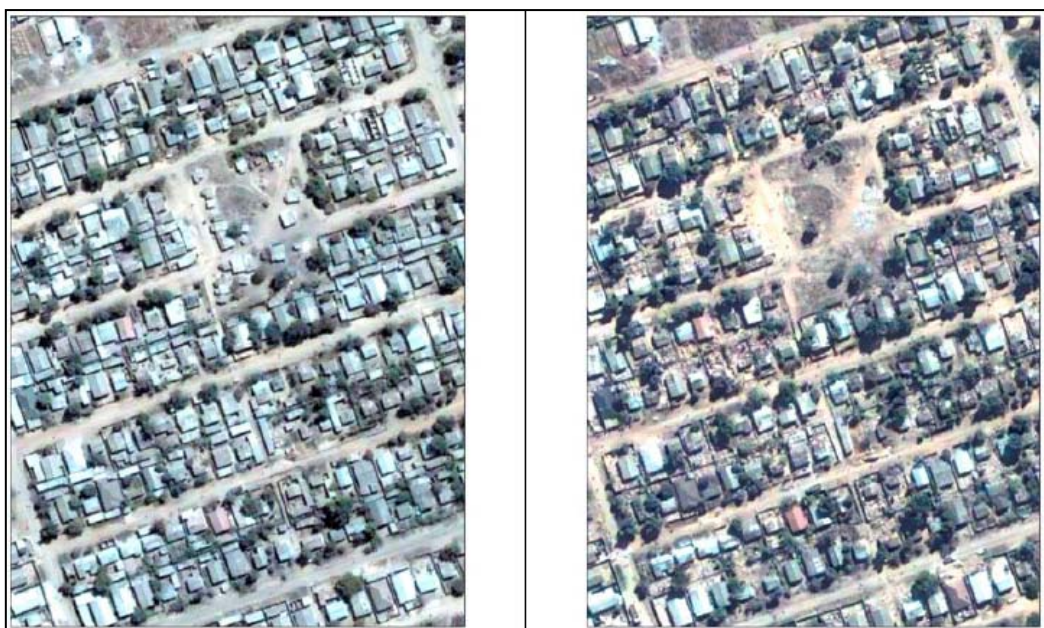
Figure 9: Chitungwiza Before and After Operation Murambatsvina

Analysis of the images indicates widespread demolition of backyard homes. Backyard homes were essentially built on small patches of land leased to renters by owners of larger, permitted structures (see Figure 9). Amnesty International researchers visited the St. Mary’s area in August 2005, at which time the evidence of the demolitions was widespread. Almost every house in St. Mary’s was surrounded by the brick rubble of destroyed backyard structures. Foundation slabs were clearly visible in many cases, and people were evidently living in the gardens and on verandas.

A subset of the high-resolution satellite imagery of Chitungwiza town in Zimbabwe. Backyard homes are visible in the left-hand (before) image and are the smaller structures found on the periphery and in the alleys of larger structures, which are absent from the right-hand (after) image. In addition, what appears to be a marketplace seen in the “before” image is absent from the after image.

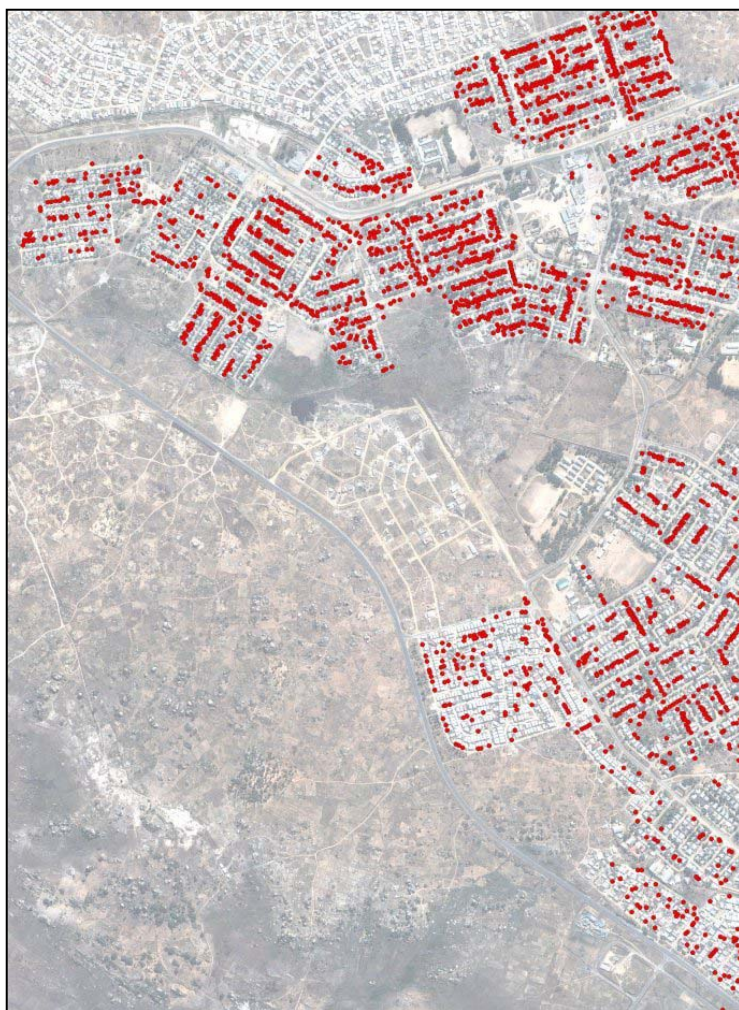
Figure 10: Chitungwiza Structure Count

Analysis of the satellite images shows more than 2,000 backyard structures were removed in the portion of Chitungwiza captured by the satellite image. In addition, at least one marketplace in Chitungwiza was destroyed during the operation. In total, analysis of the satellite imagery indicates that 2470 structures were removed from this portion of Chitungwiza during Operation Murambatsvina. The size of structures themselves varied quite widely, with small backyard homes measuring 4 meters on a side and larger market structures measuring up to 40 square meters and more.

Chitungwiza on 22 June 2005 with centre points of the 2470 removed structures.
Images (C) COPYRIGHT 2006 DigitalGlobe, Inc. ALL RIGHTS RESERVED.

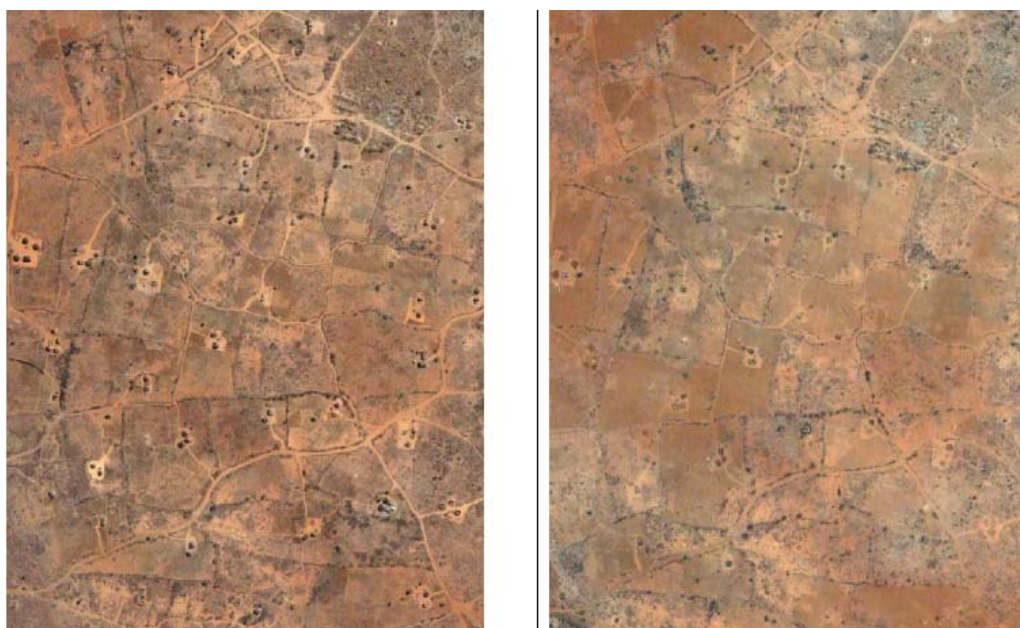
Figure 11: Killarney Before and After Operation Murambatsvina

The informal settlement at Killarney, outside Bulawayo, was destroyed in June 2005 as part of Operation Murambatsvina. Two QuickBird images were obtained covering the area including a “before” image from 22 August 2004 and an “after” image from 7 September 2005.⁹ The satellite imagery clearly shows the settlement in 2004 while the 2005 image shows most homes removed.

A subset of the high resolution satellite imagery of the Killarney settlement in Zimbabwe. Note that the entire settlement of Killarney that was destroyed measured more than three kilometers from north to south and 1.6 kilometres east to west. Given the small size of the structures, they would not be visible were the full extent of the image shown. Some of the more than 465 Killarney structures are visible in the before (left hand) image, most of which are absent from the after (right hand) subset image. Images (C) COPYRIGHT 2006 DigitalGlobe, Inc. ALL RIGHTS RESERVED.

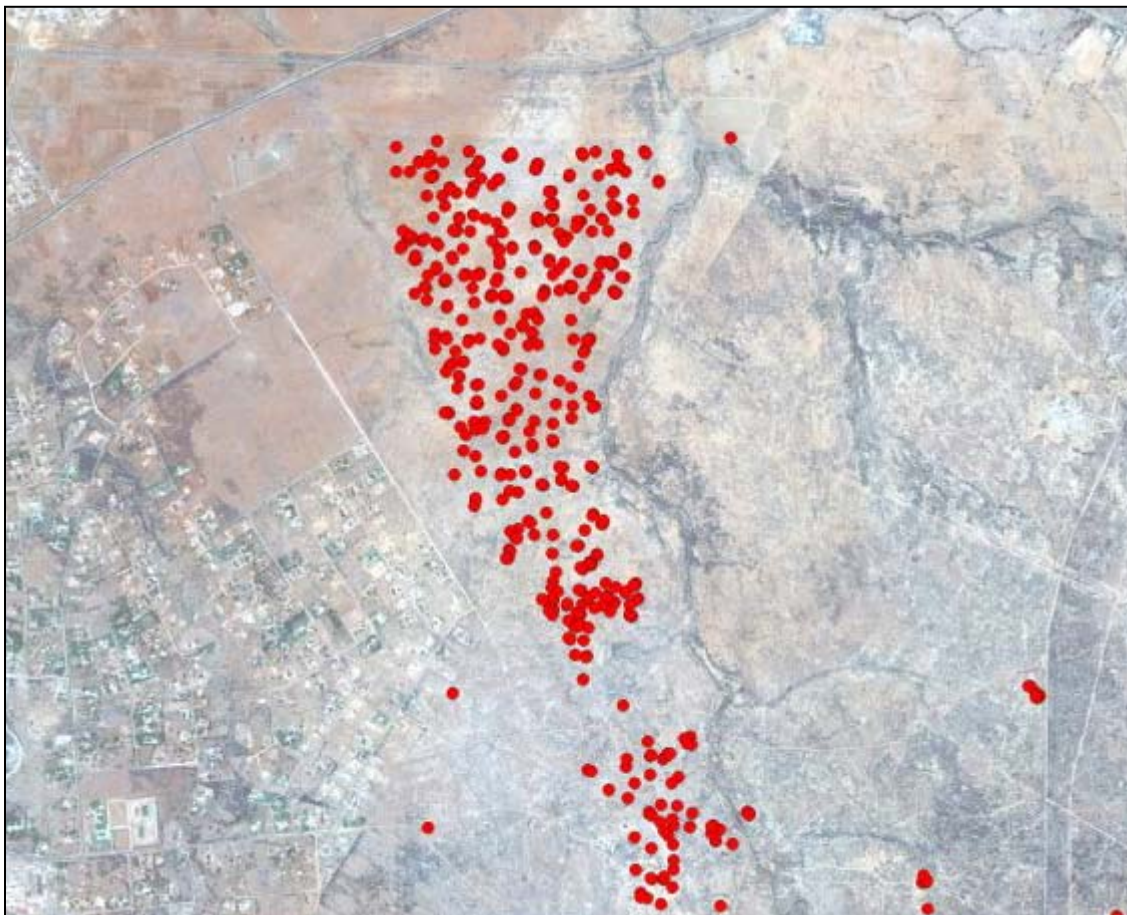
Figure 12: Killarney Structure Count

A total of 486 structures were counted in the primary area of removal. The sizes of the structures themselves were generally quite small, measuring four meters on a side and smaller. One household many have comprised several small buildings.

The informal settlement of Killarney (removed structures too small to be seen at this resolution). Centre points of the 486 removed structures.
